**Marine Biological Survey
Pinellas County Shore Protection Project
Comprehensive Borrow Area Study**

February 2002

**Prepared for:
Jacksonville District
U.S. Army Corps of Engineers
400 West Bay Street
Jacksonville, FL 32202**

**Prepared by:
Dial Cordy and Associates Inc.
490 Osceola Avenue
Jacksonville Beach, FL 32250**

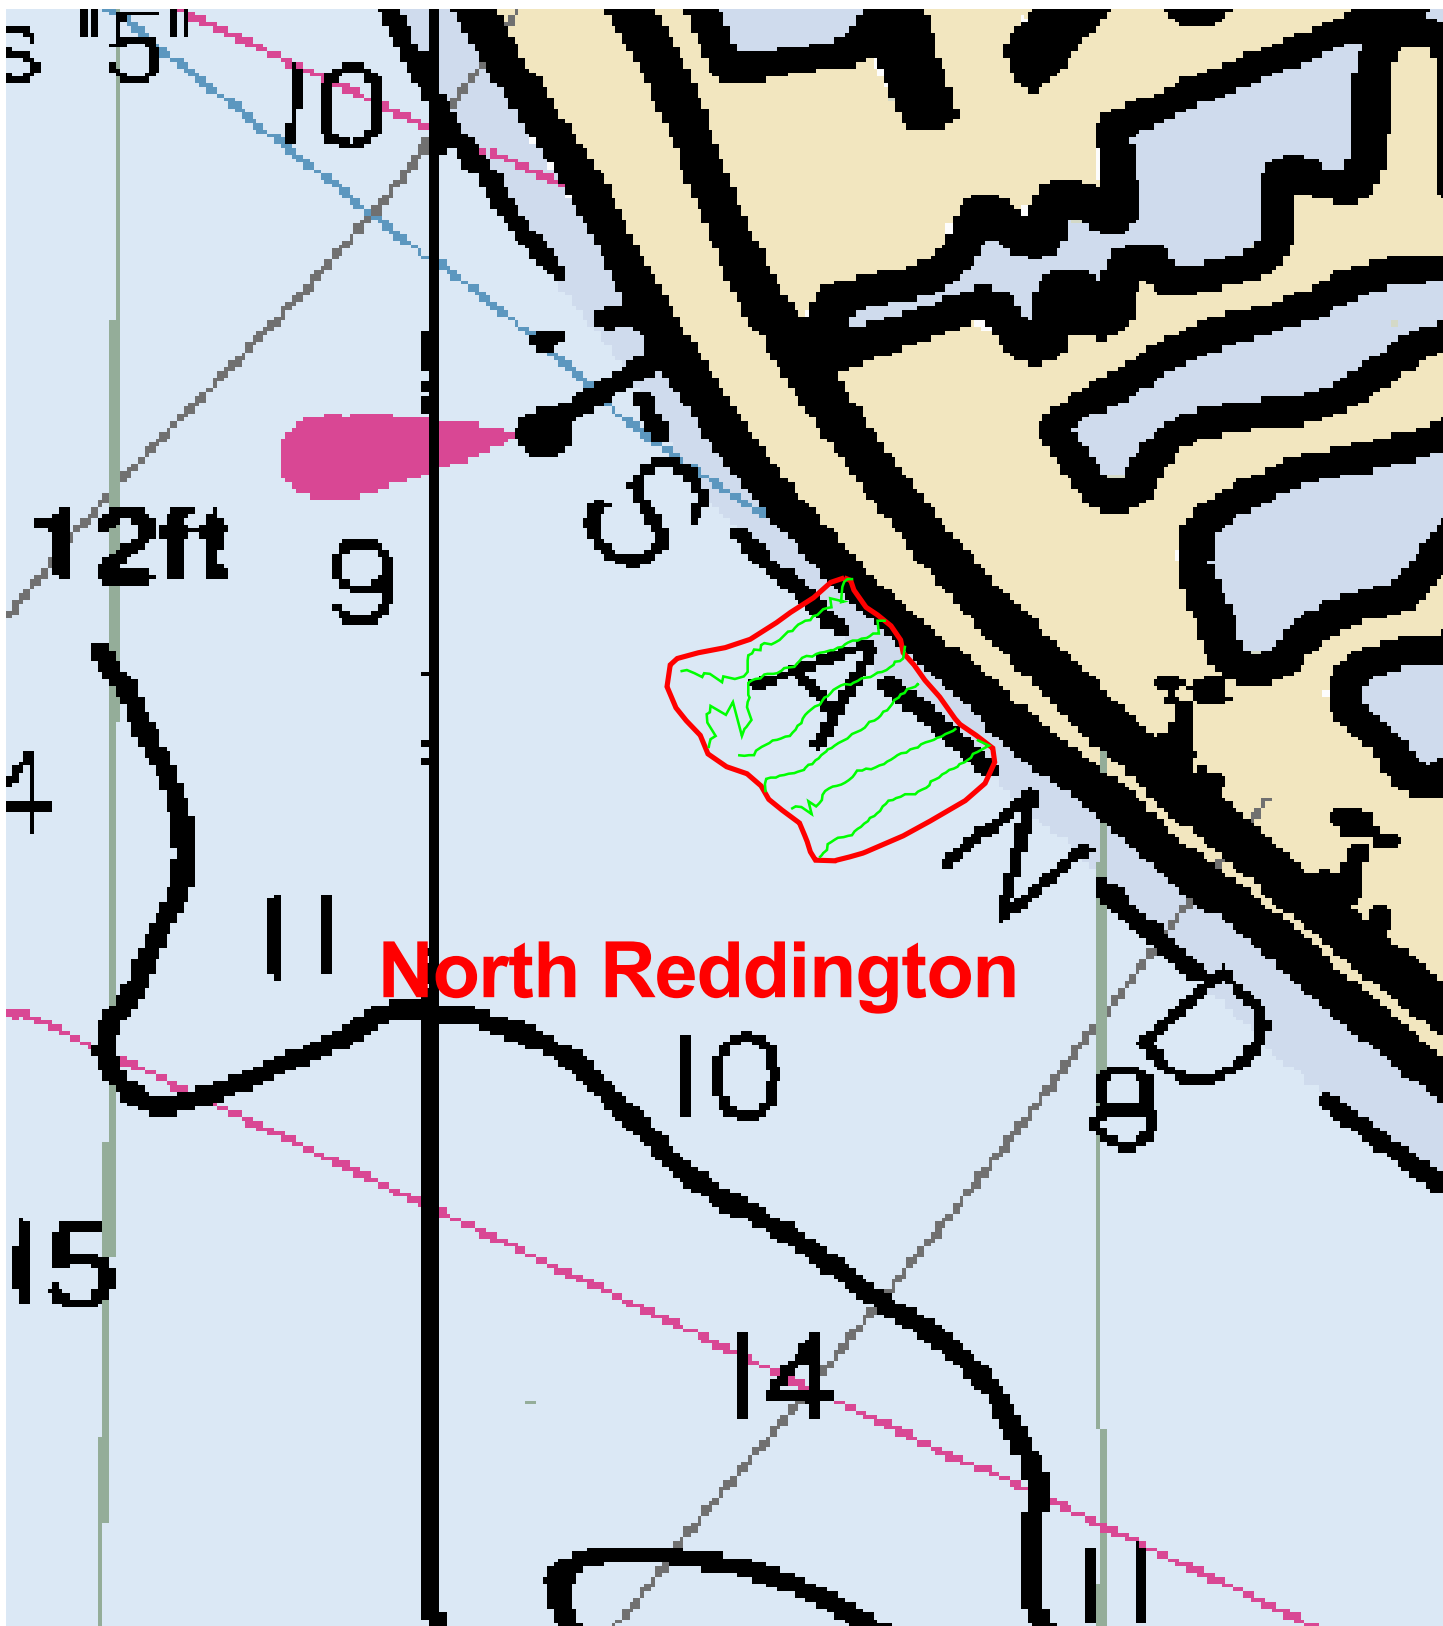
Figure 10

North Reddington Transect Survey Lines

To identify and delineate any marine resources present within the proposed borrow areas, a towed video survey was conducted. A towed video camera, in conjunction with Differential Global Positioning System (DGPS) and HYPACKMAXTM navigation software, was utilized. Real time position of the camera was overlaid on the digitally recorded survey record. Transects were established within each borrow area at 500-foot intervals. In total, over 350 nautical miles of transect lines encompassing over 13,800 acres were surveyed (Figures 5-11).

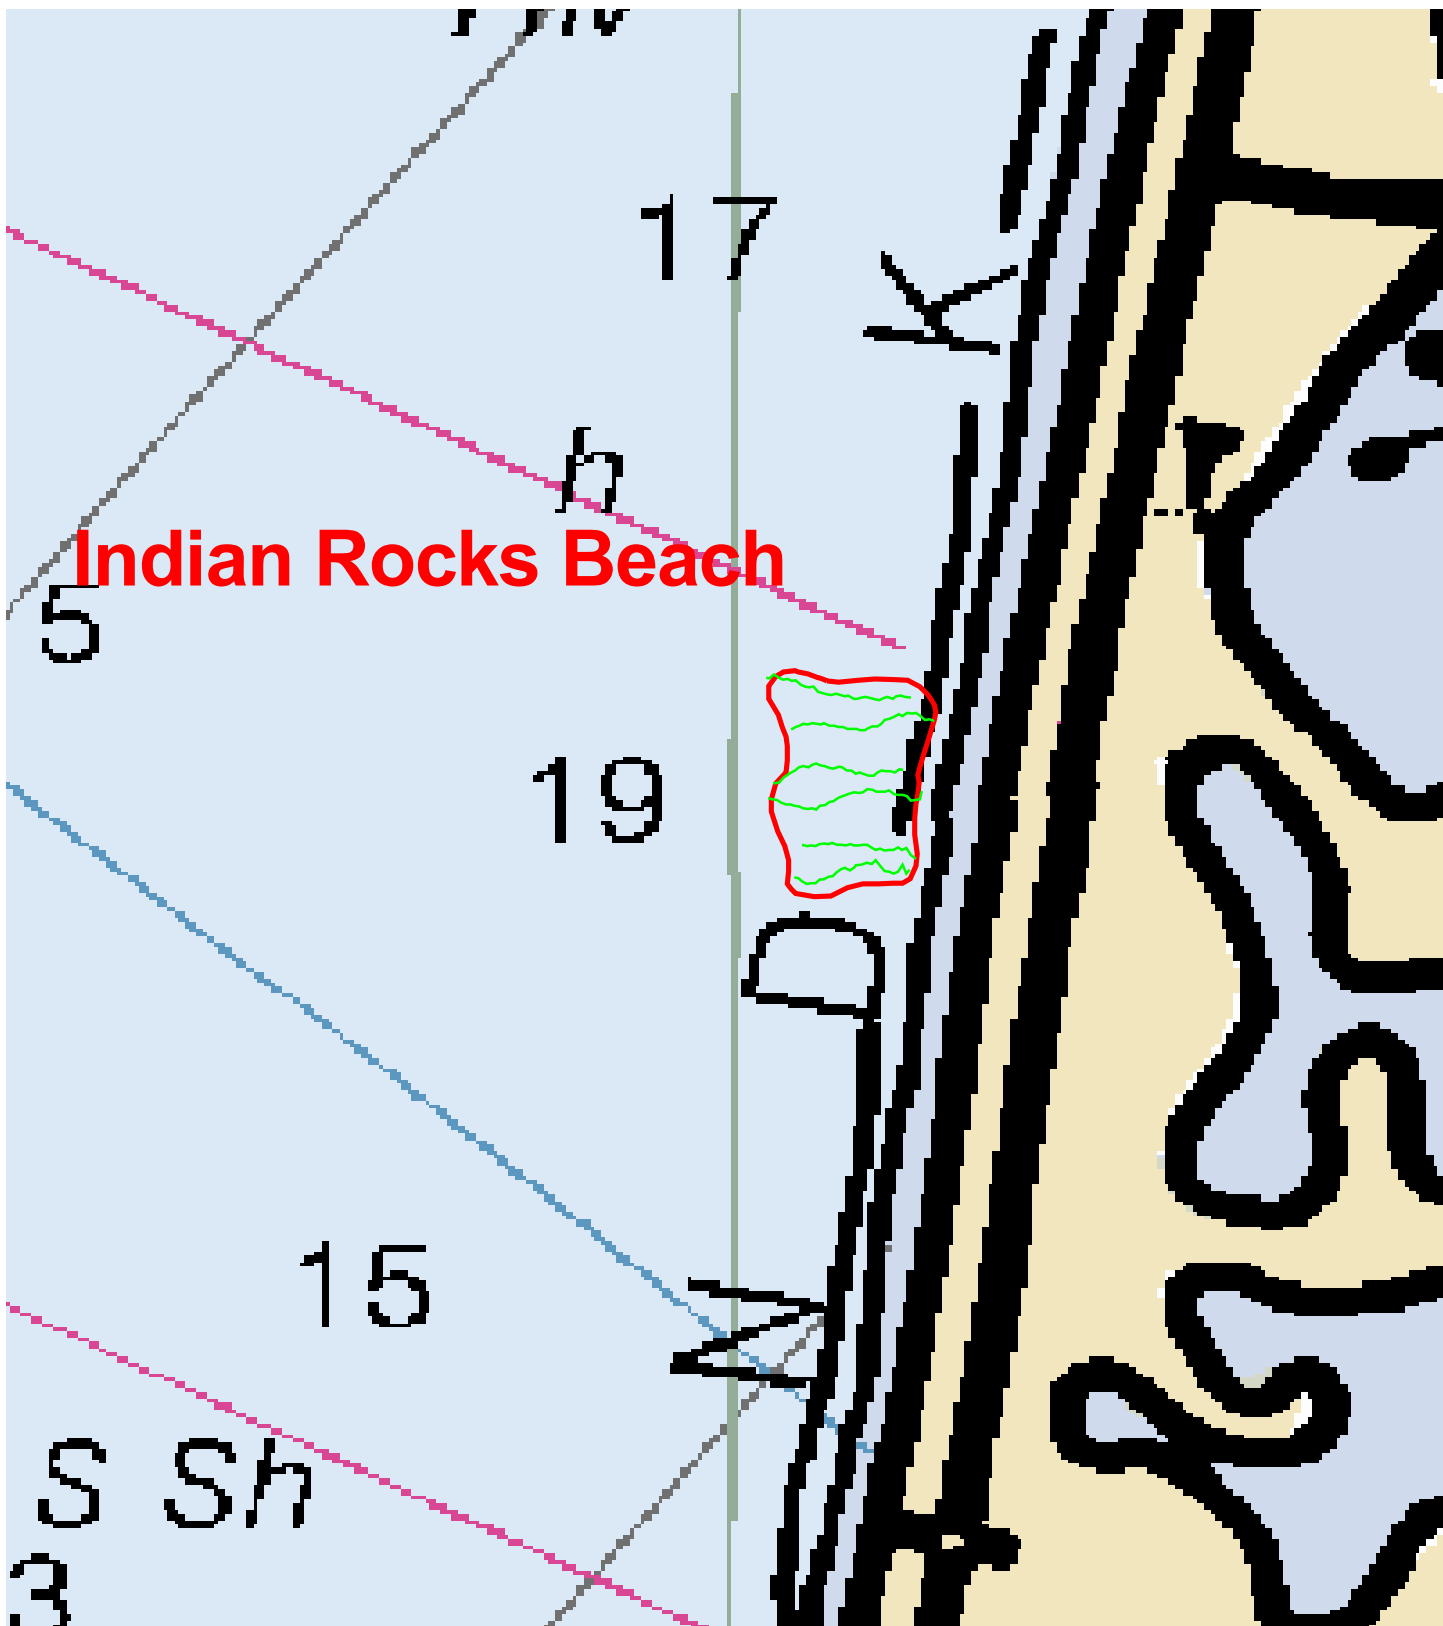
Figure 11

Indian Rocks Beach Transect Survey Lines

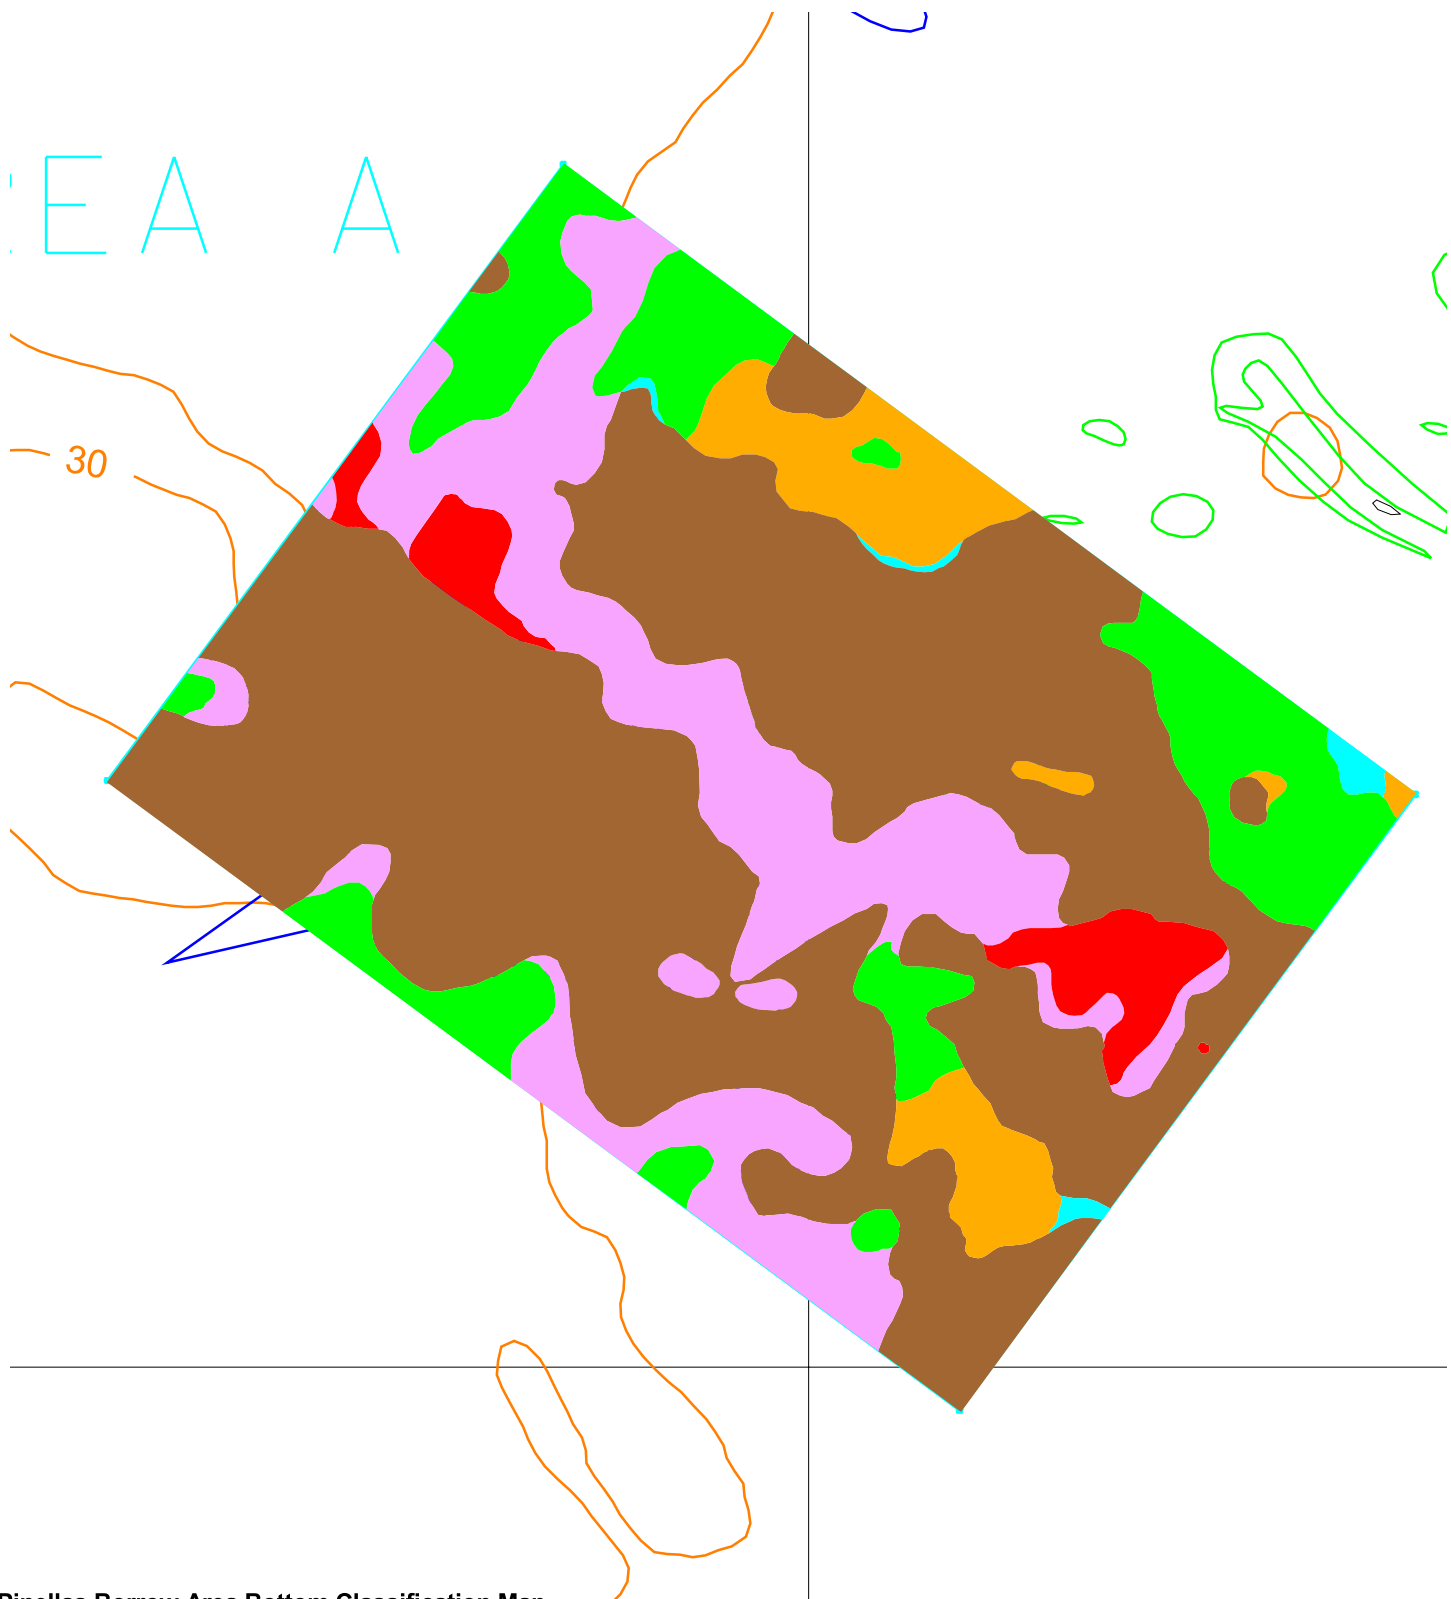
DIAL CORDY AND ASSOCIATES INC. Environmental Consultants	J01-493
	Figure 12

Borrow Area A has the most exposed hardbottom areas of all of the areas mapped. Most of the 880 acres of hardbottom within Area A consists of scattered medium relief habitats. In total 390 acres of the hardbottom habitat is scattered medium relief hardbottom, 126 acres of

Pinellas Borrow Area Bottom Classification Map

scattered low relief hardbottom, with the remaining 249 acres being dense medium/high relief habitat (Table 6). Relief within Area A averages 32 cm and is predominately low-lying sponges, gorgonians, and hard corals. Photograph 1 shows a typical area of exposed hardbottom with relief. Hardbottom in Area A is dominated by gorgonian and sponge species. In particular, *Muricea* sp., and *Pseudopterogonia* sp. tended to be dominant. *Echinometra lucunter* and *Luidia* sp. were the most common motile invertebrates encountered. Overall, hardbottom habitats within Area A tended to be of medium quality. In areas that diver surveys were conducted there tended to be a high degree of siltation present with many corals and sponges slightly covered. Gorgonian species, with a higher relief when compared to the low lying rock, tended to be the healthiest species present. Fish species encountered within Area A included *Equetus umbrosus* and *Opsanus beta*.

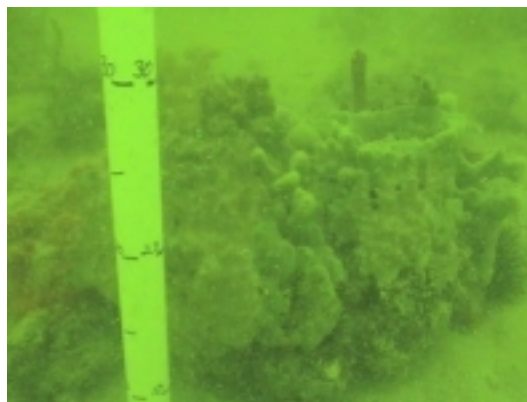
Photograph 1. Area A scattered medium relief hardbottom.

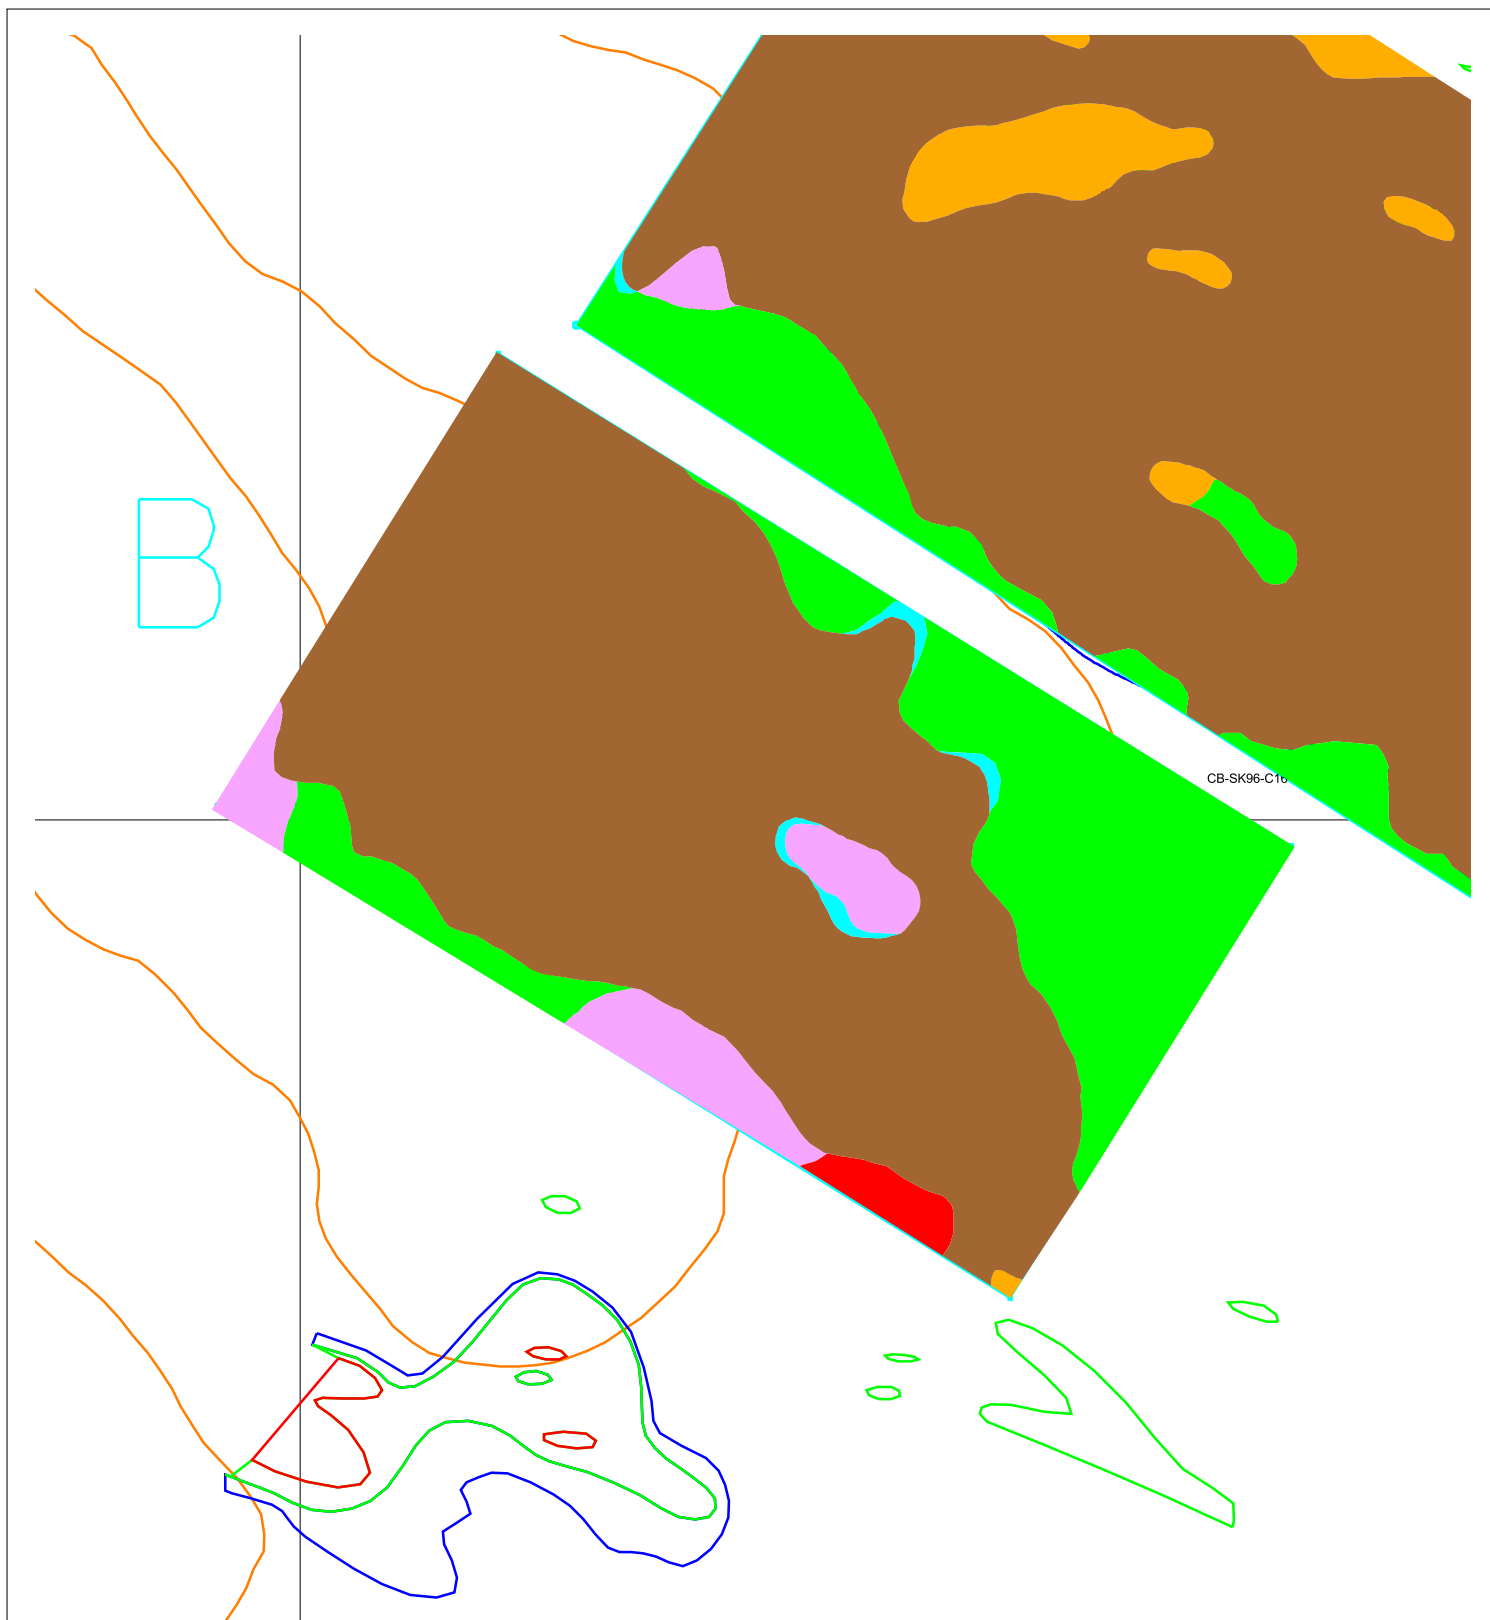
DIAL CORDY AND ASSOCIATES INC. Environmental Consultants	J01-493
	Figure 13

Pinellas Borrow Area Bottom Classification Map

- Dense Hardbottom (>75% Cover), High Relief (>100 cm)
- Dense Hardbottom (>75% Cover), Medium Relief (30cm-100cm)
- Scattered Hardbottom (20% - 75% Cover), Medium Relief (30cm-100cm)
- Scattered Hardbottom (20% - 75%, Cover), Low Relief (<30cm)
- Patchy Hardbottom (<20% Cover), Low Relief (<30cm)
- Sand

Dense hardbottom habitats within Area C tended to have a relatively higher quality and diversity in comparison to other offshore areas surveyed. Overall there was a total of 93.2 acrea of dense medium/high relief hardbottom and 154.5 acres of scattered low/medium relief hardbottom in Area C (Table 6). Of particular note within this area, there were colonies of the hard corals *Solenastrea hyades* and *Oculina robusta* and also barrel sponges (*Xestospongia muta*). Fishes were more common in this area with sand divers (*Synodus intermedius*), toadfish, and slipperly dicks along with schools of menhaden (*Brevoortia* sp) and spotfin pinfish (*Diplodus holbrooki*) observed (Photograph 3). Also observed within this area was the commercially important stone crab (*Menippe mercenaria*). Typical relief of hardbottom within Area C was 20 cm (Photograph 4). In some areas, where gorgonian species such as *Pterogorgia anceps* were present, the relief was as high as 40 cm, however.

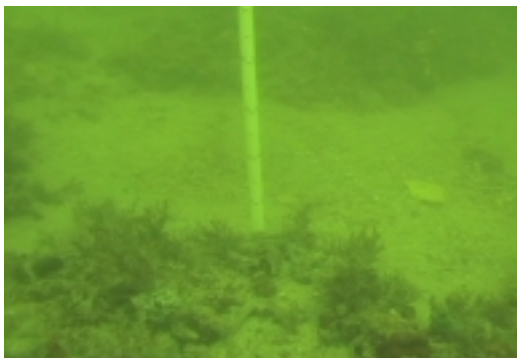
flabellum, and *Sargassum* sp. were the most visible algal species. Sponges in the area included *Ircinia* sp. and *Cribrochalina vasculum*. One noticeable feature of the areas where SCUBA reconnaissance was conducted in Area B was the lack of gorgonian species in these hardbottom areas. Invertebrate species common to the area included *Luidia* sp, and the whelk, *Busycon contrarium*. Photograph 2 shows typical hardbottom coverage in Area B with vertical relief shown.

Photograph 2. Area of scattered low relief hardbottom in Area B.

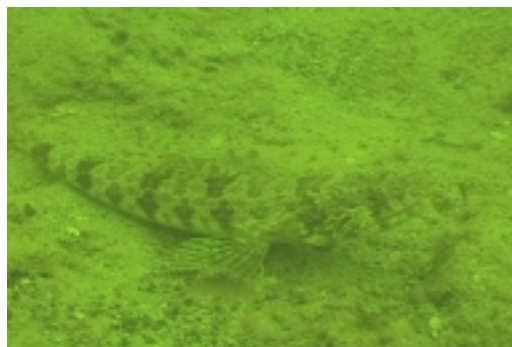
Photograph 3. Sand Diver (*Synodus intermedius*) in Area C.

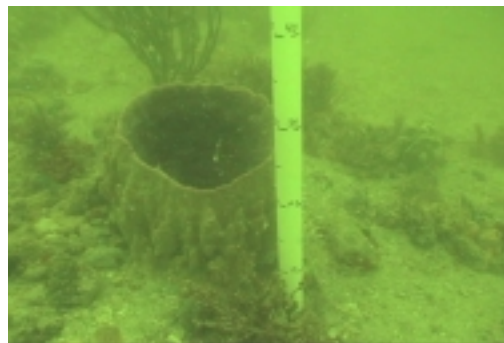
Photograph 4. Area C Hardbottom with Relief Shown

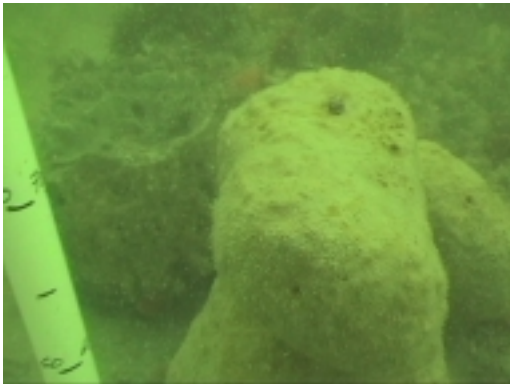
Photograph 5. Large sponges with relief shown in Area D

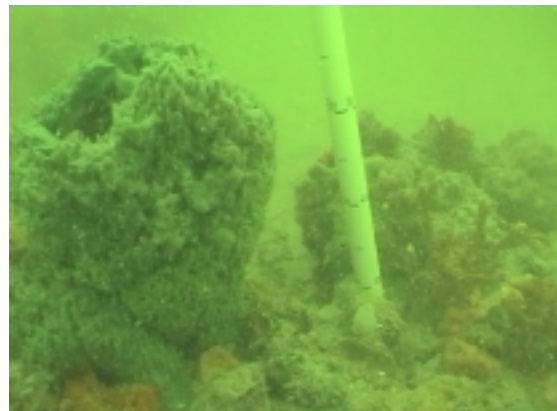
Photograph 6. Typical scattered low relief hardbottom in Area E.

hardbottom features averaged 36 cm, with 292.9 acres of low/medium relief patchy and scattered habitat. Photograph 6 depicts typical hardbottom features in Area D with relief shown. Fishes were also common in the hardbottom areas within Area D, and included sand divers, juvenile grunts, blennies, and sheepshead (*Archosargus probatocephalus*) were observed within the area. A large sharksucker (*Echeneis naucrates*) was also seen in the area.

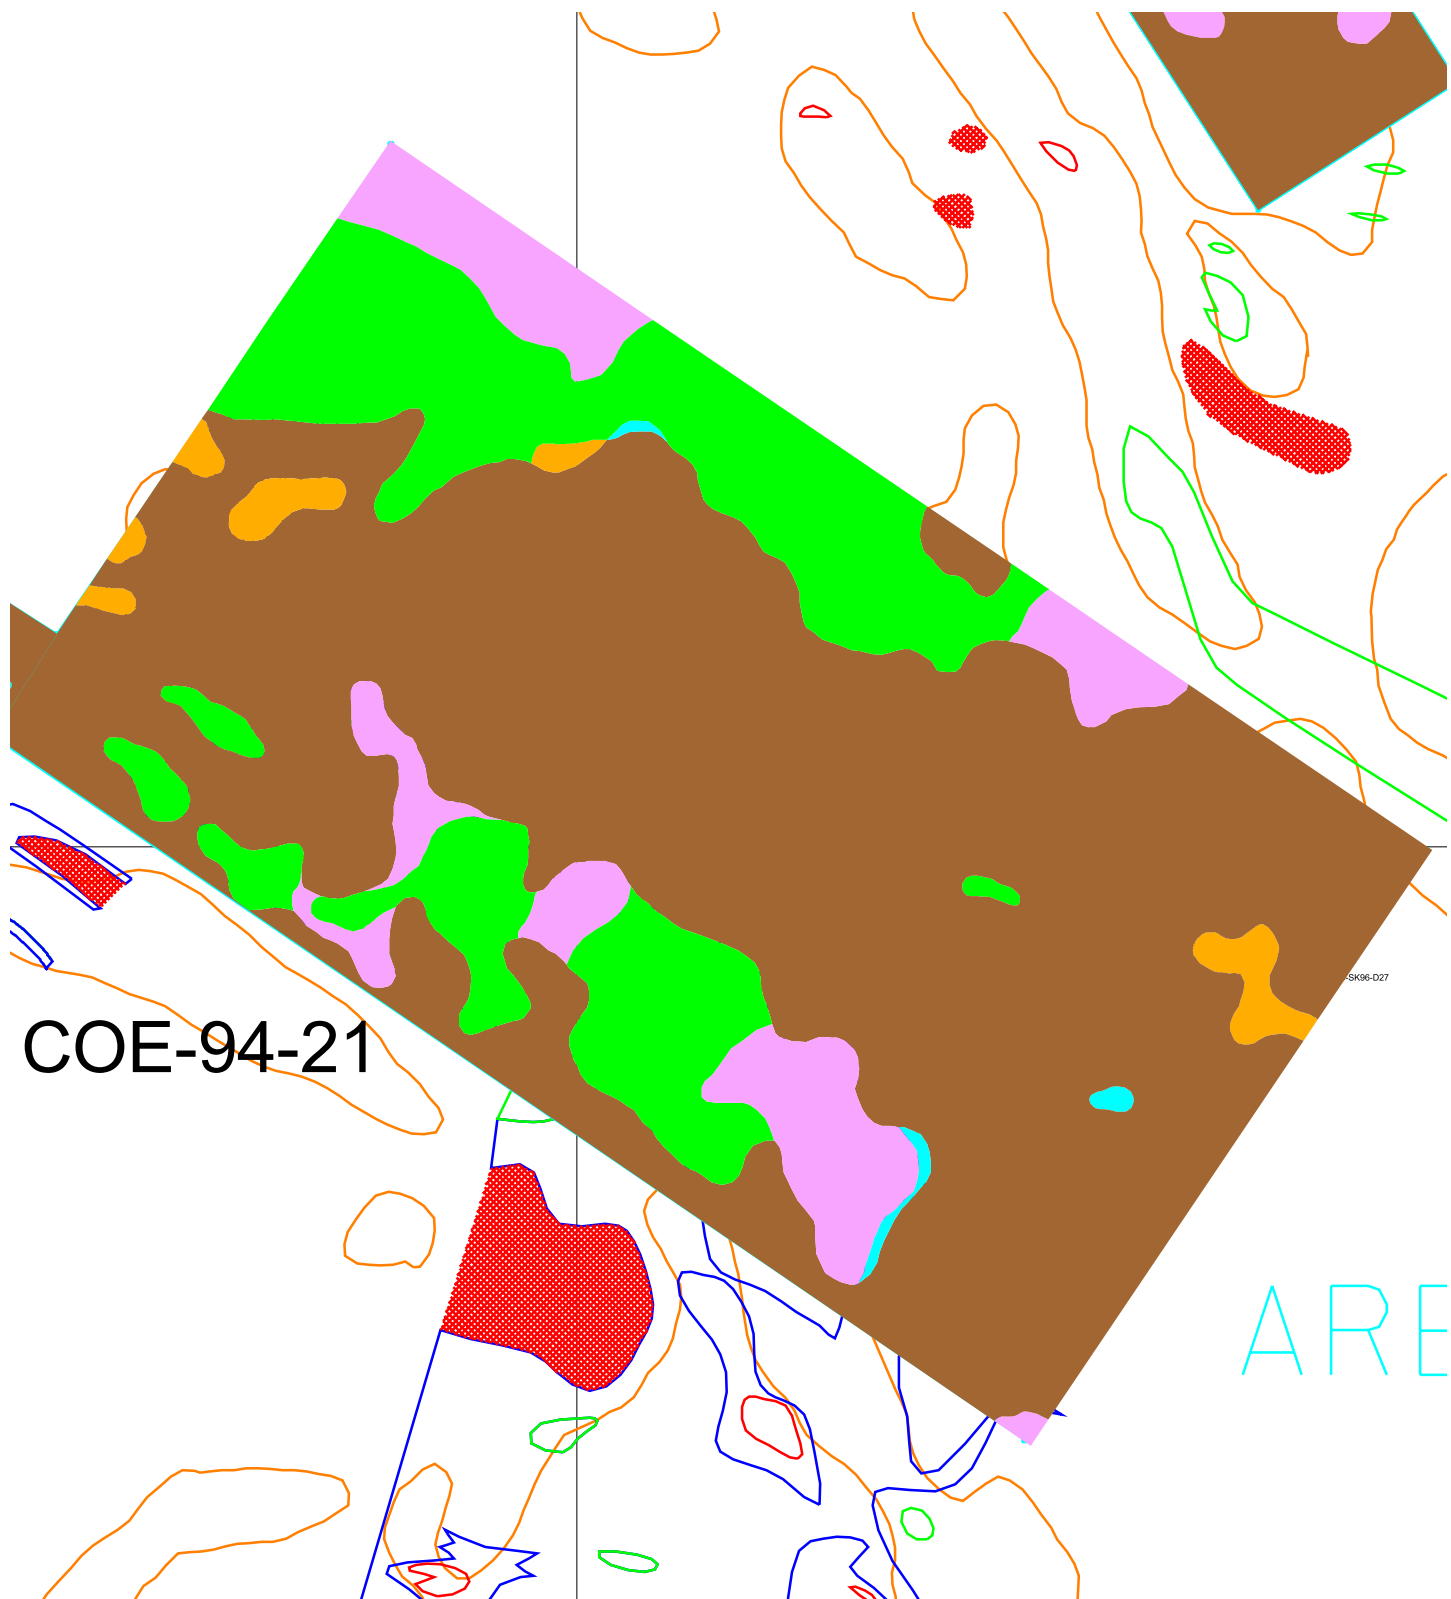
DIAL CORDY AND ASSOCIATES INC. Environmental Consultants	J01-493
	Figure 16

Pinellas Borrow Area Bottom Classification Map

- Dense Hardbottom (>75% Cover), High Relief (>100 cm)
- Dense Hardbottom (>75% Cover), Medium Relief (30cm-100cm)
- Scattered Hardbottom (20% - 75% Cover), Medium Relief (30cm-100cm)
- Scattered Hardbottom (20% - 75% Cover), Low Relief (<30cm)
- Patchy Hardbottom (<20% Cover), Low Relief (<30cm)
- Sand

Offshore Borrow Area E is the second smallest area surveyed at 592.7 acres (Figure 16). Within this area, the survey revealed 201.8 acres of hardbottom habitat and 390.9 acres of open sand habitat. Borrow Area E is 2.5 miles west of Indian Rocks Beach.

Marine resources in Area E were predominately comprised of low/medium relief exposed rock features (Figure 16) (Table 6). In total, 134.9 acres of habitat were scattered low/medium relief hardbottom. In most areas the hardbottom features were merely scattered rock/rubble with associated sponges, algae, and coral (Photograph 6). Large areas adjacent to and among these rubble areas consisted of large octocorals (*Pseudoterogorgia sp.*, *Plexaurella nutans* etc.) (Photograph 7). Within these areas of dense gorgonians, the relief averaged over 50 cm. The surrounding rock features in the area had average relief of less than 20 cm.

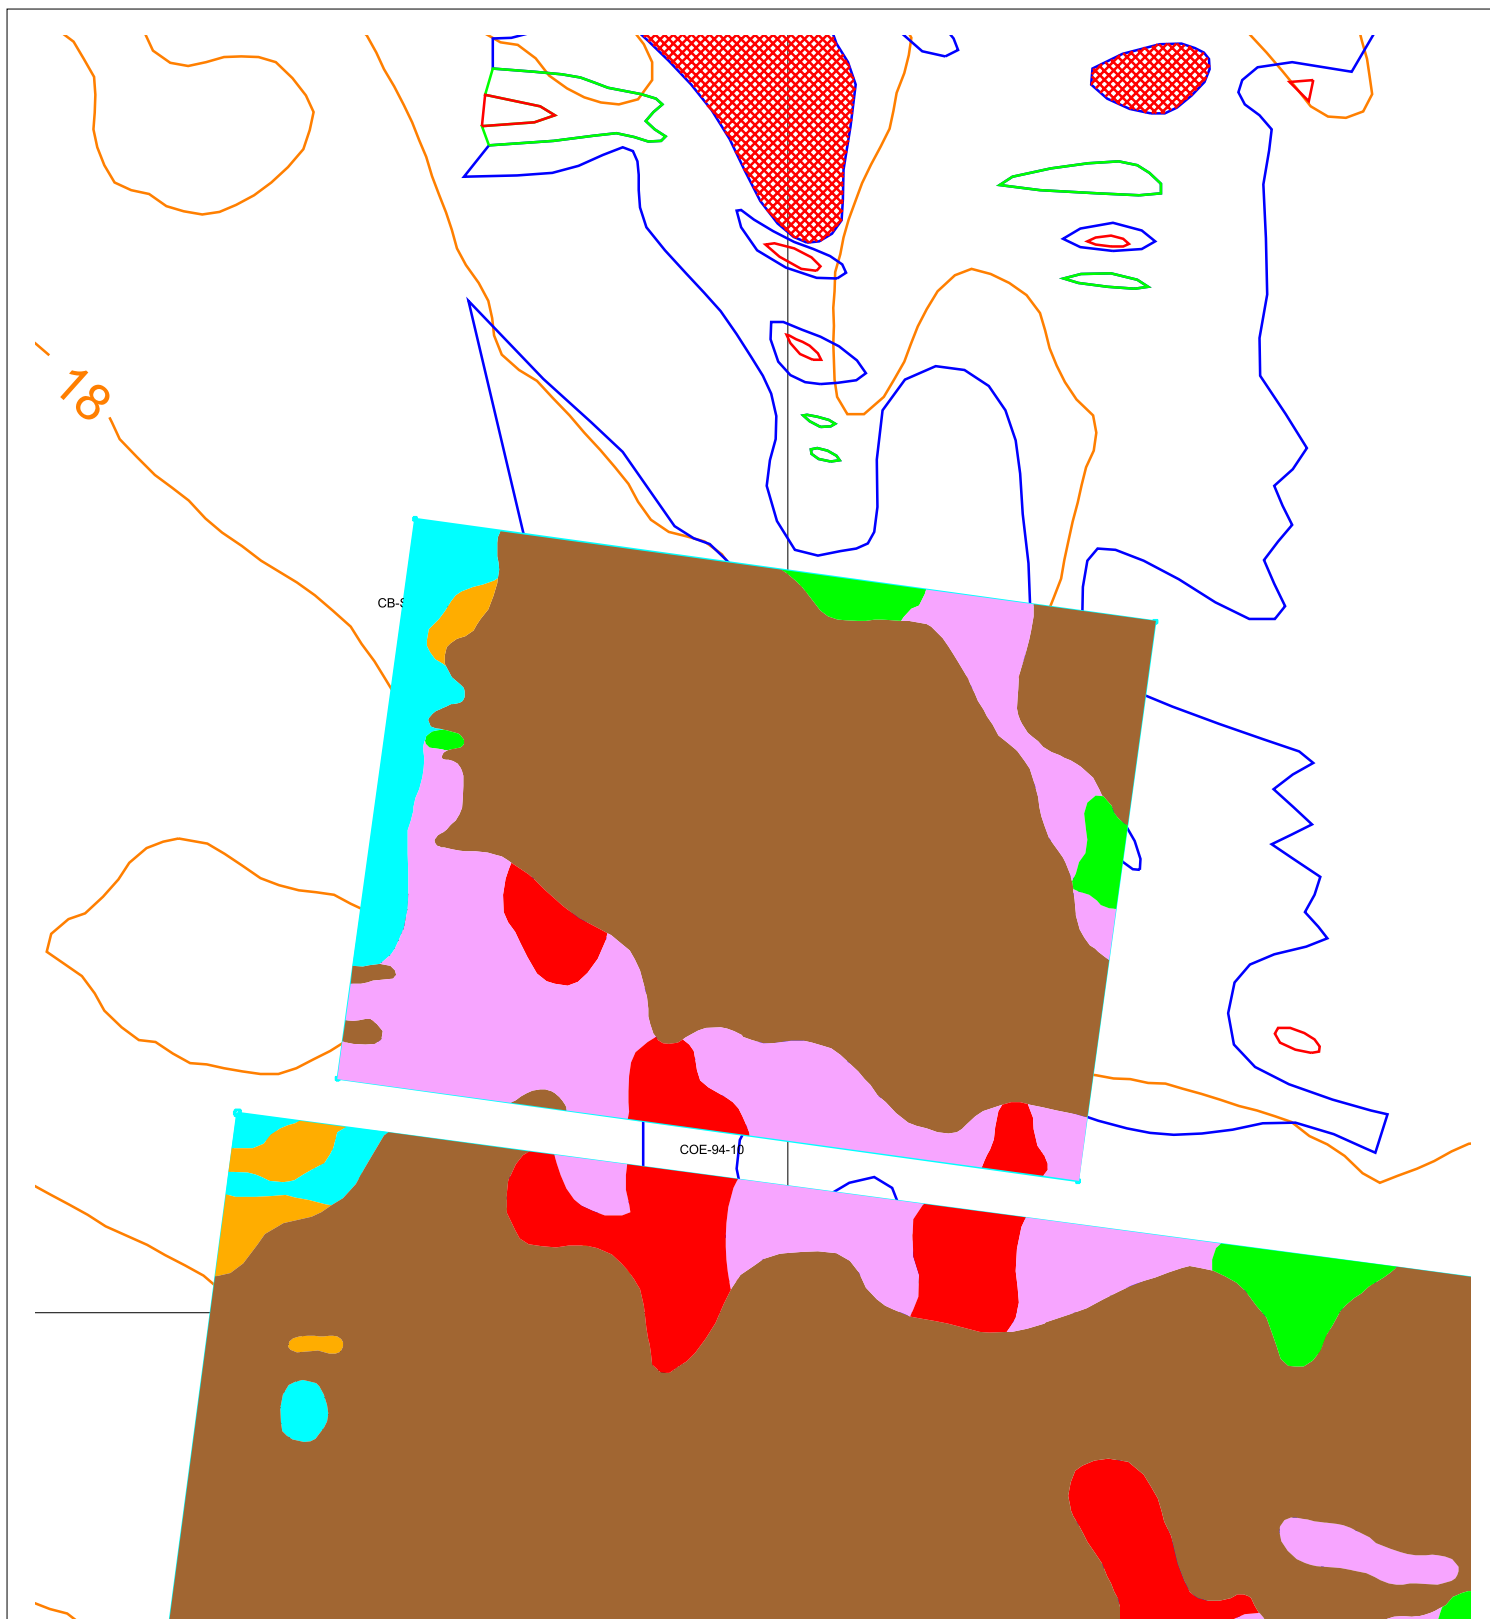
Pinellas Borrow Area Bottom Classification Map

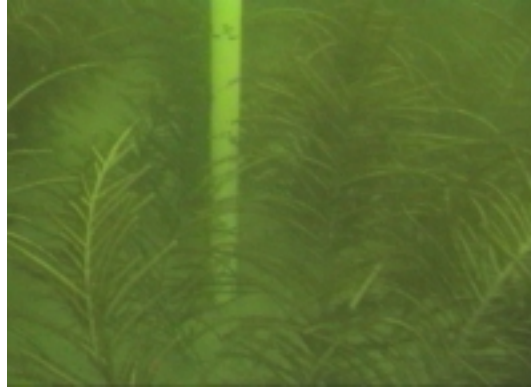
Photograph 7. Octocoral community within Area E

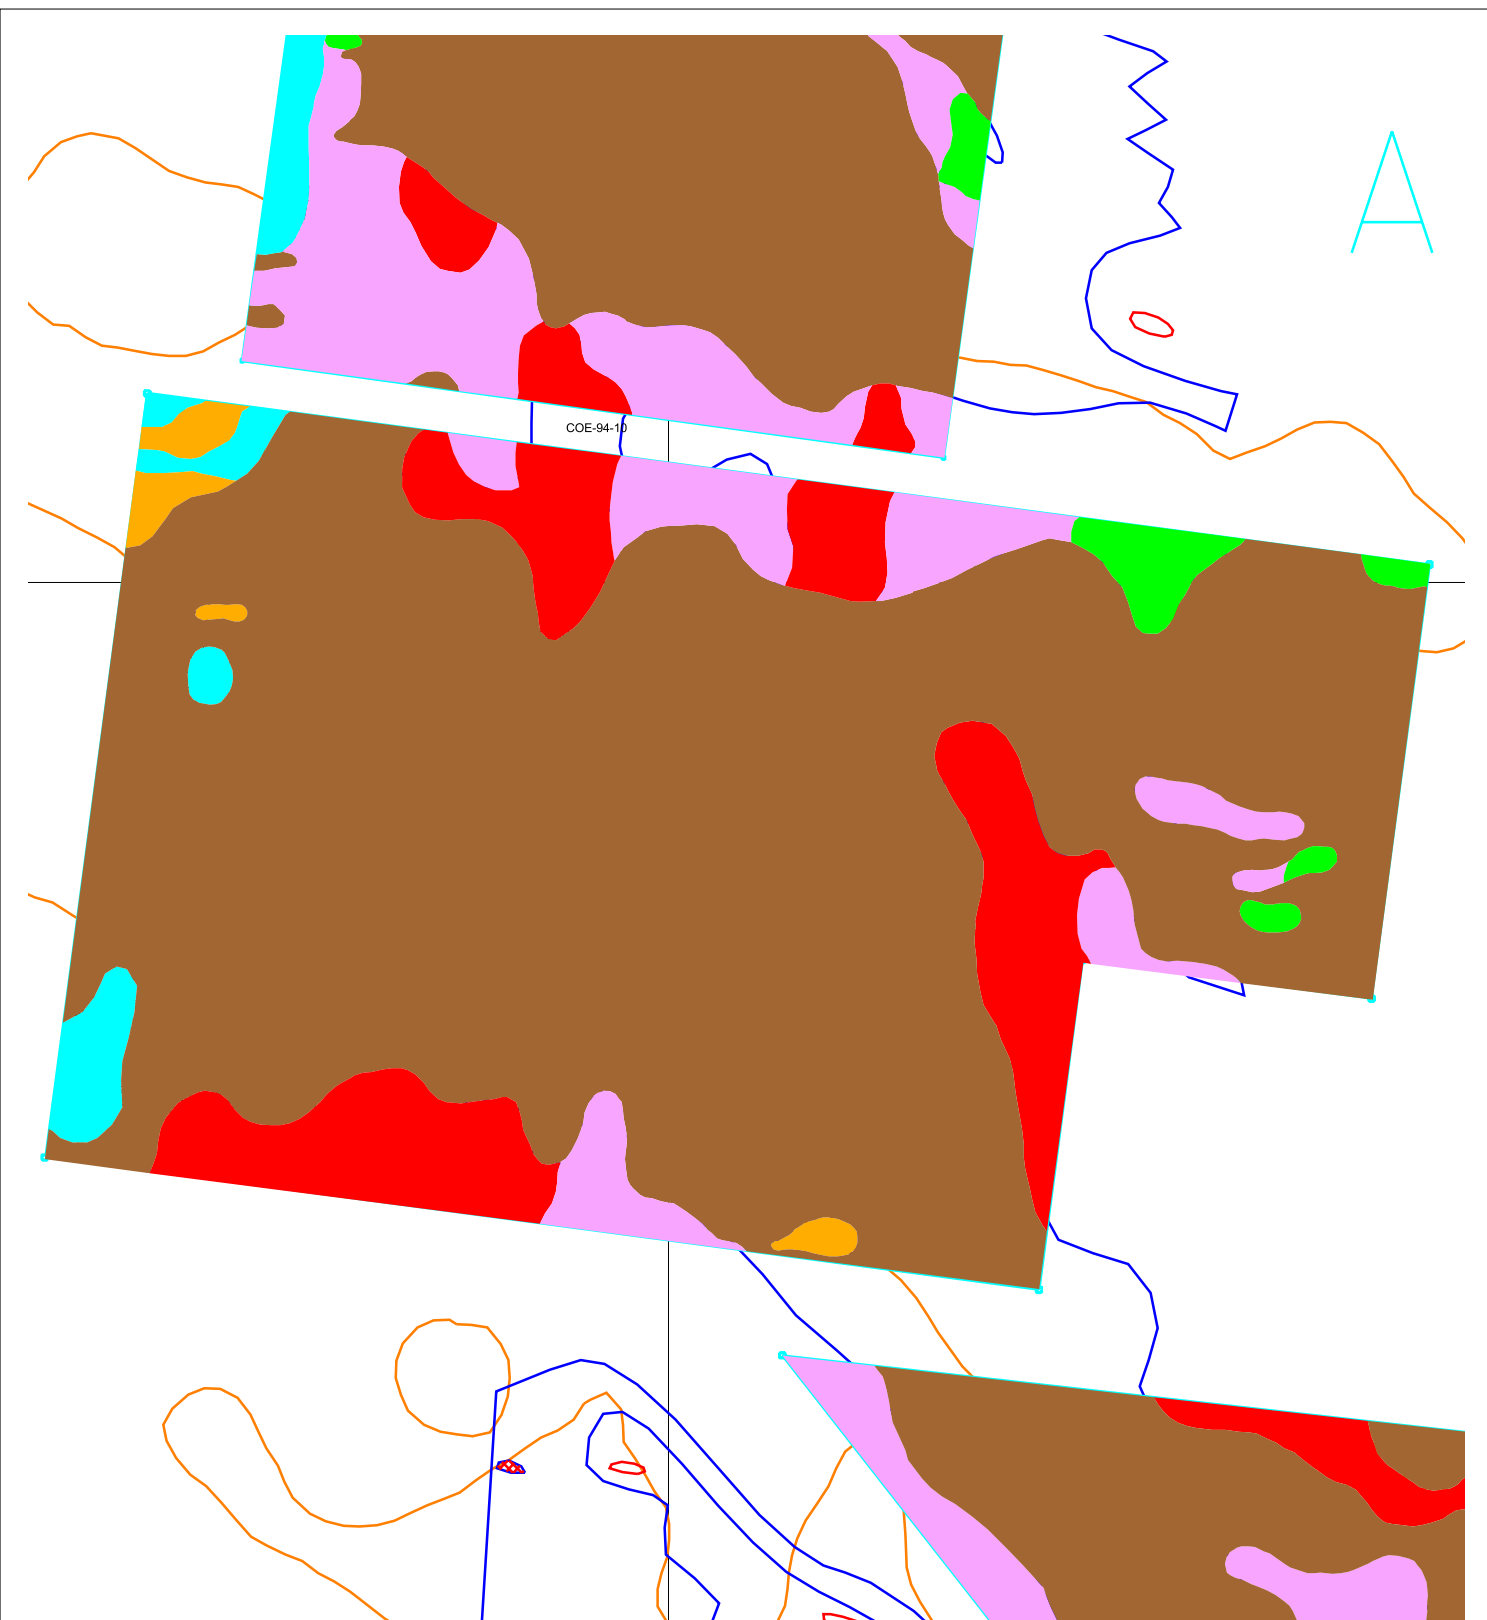
DIAL CORDY AND ASSOCIATES INC. Environmental Consultants	J01-493
	Figure 17

Pinellas Borrow Area Bottom Classification Map

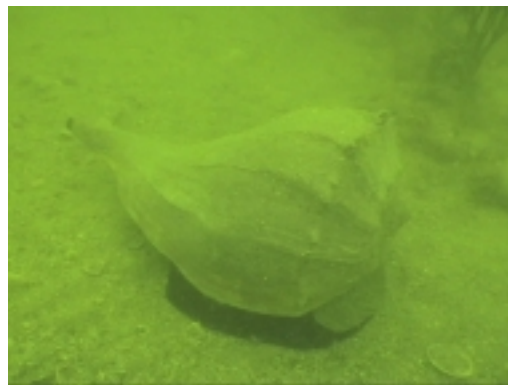
Photograph 9. Large lightning whelk found in Area F.

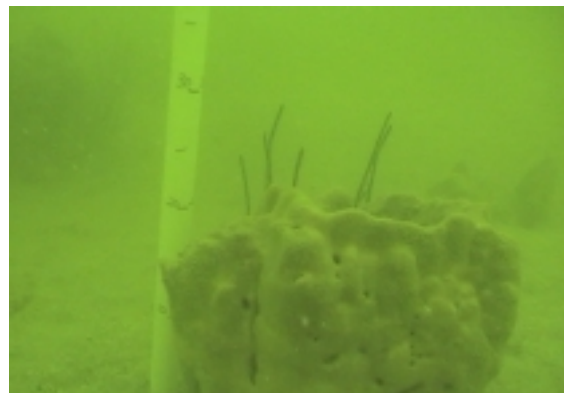
Photograph 10. Typical scattered low relief habitat in Area F.

Borrow Area F has over 187 acres of high quality dense medium/high relief hardbottom habitat (Table 6). Hardbottom areas within Area F are comprised of scleractinian species such as *Solenastrea hyades* (Photograph 8), as well as a variety of gorgonian species. Also present within this area were large overgrowing tunicates (Family Didemnidae). Fishes observed within these hardbottom habitats included numerous sea robins (*Prionous sp.*), moray eels (*Gymnothorax sp.*), and juvenile grunts. Invertebrate species encountered included the very common *Luidia clathrata*, *Lytechinus variegatus*, and *Echinometra lucunter*, as well as a very large specimen of the lightning whelk, *Busycon contrarium* (Photograph 9). Another 100 acres of scattered low/medium relief also occurs within this area. A typical view of this relief is shown in Photograph 10.

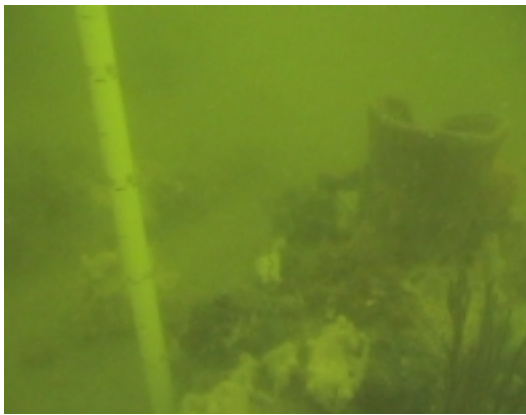
Photograph 11. Typical relief of scattered medium relief habitat in Area G.

With a vertical relief of 35 cm, the scattered medium relief hardbottom present within Area G represented some of the highest quality hardbottom encountered during the survey. Large gorgonian species interspersed with large sponges and hard corals typified the area. Photograph 11 shows some of the typical relief within the area. Some areas within Area G had a relief of over 50 cm. *Ircinia* sp., *Cribrochalina vasculum*, and *Spheciospongia vesparium* were the most common porifera species encountered. The gorgonian, *Leptogorgia virgulata*, was also common within the area.
